Manual TP-0445

# Parts Failure Analysis

This publication provides a parts analysis process to help you determine why parts failed during operation, what to look for when you inspect parts, and how to help prevent failures from occurring again.

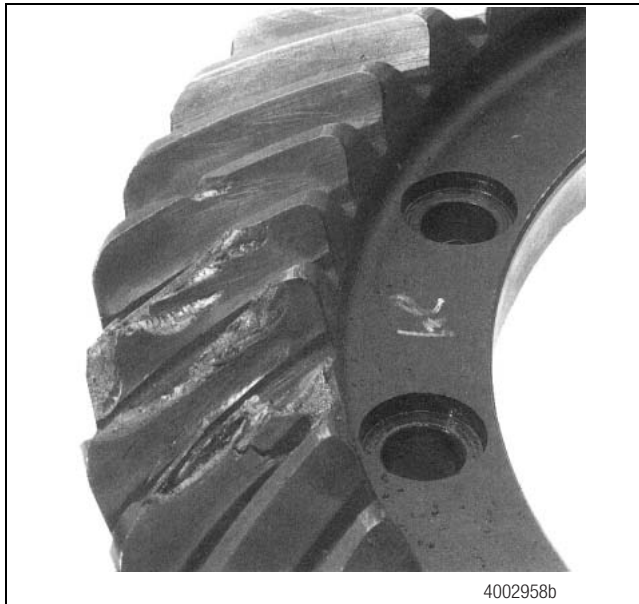
**Figure 1.1**

This publication provides a parts analysis process to help you determine why parts failed during operation, what to look for when you inspect parts, and how to help prevent failures from occurring again. Figure 1.1, Figure 1.2 and Figure 1.3 are examples of failed parts.

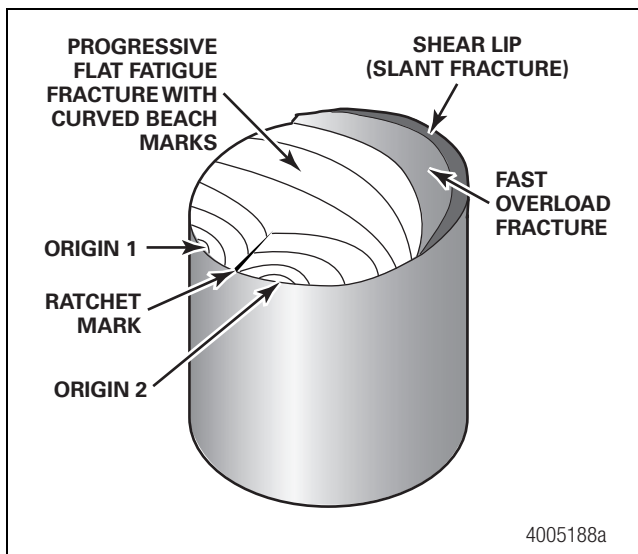
Figure 3.1

Beach marks represent fatigue cycles that occurred before the component failed completely. Visually, beach marks are often compared to the rippling effect of a stone thrown into calm water. Figure 3.1.

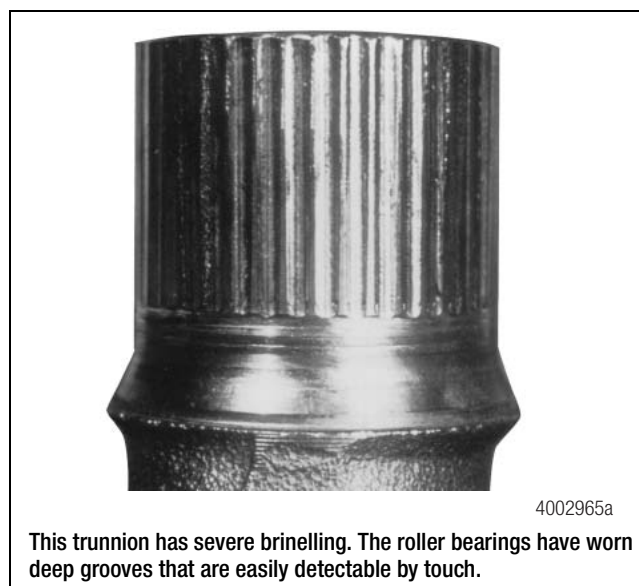
Figure 3.6

Brinelling is a type of surface fatigue that causes bearing rollers to wear deep grooves into the mating surface. Figure 3.6. Brinelling of a u-joint usually occurs when load applications exceed the vehicle's rating, which can also cause parts to spall from uneven load application.

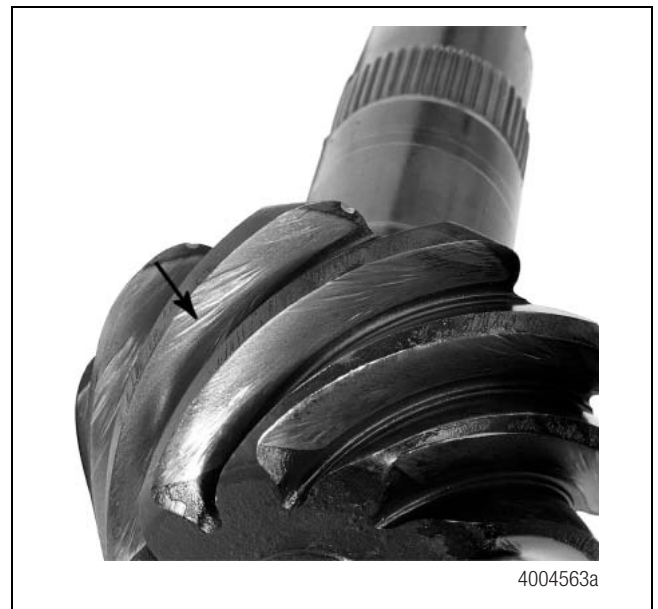
Metal-to-metal contact occurs, which causes friction to damage parts. Figure 3.9 and Figure 3.10.

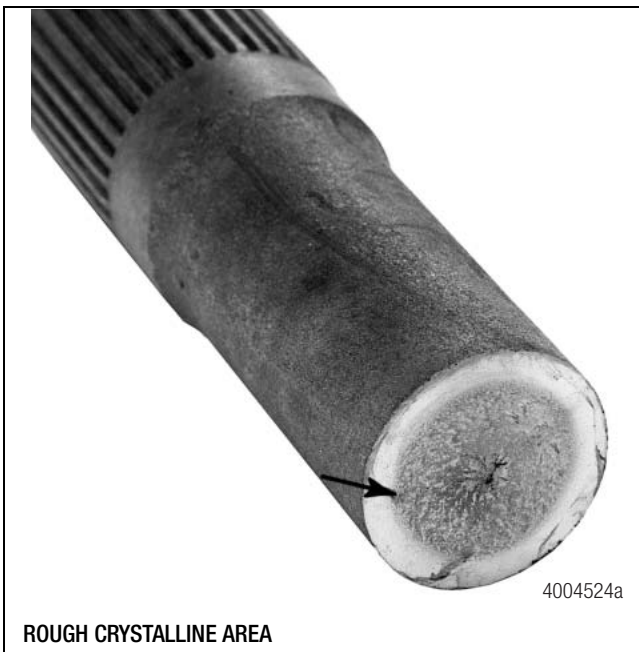
**Figure 3.11**

When a sudden, severe impact load occurs, the wear pattern that forms on the surface of the part resembles crystal facets. Figure 3.11.

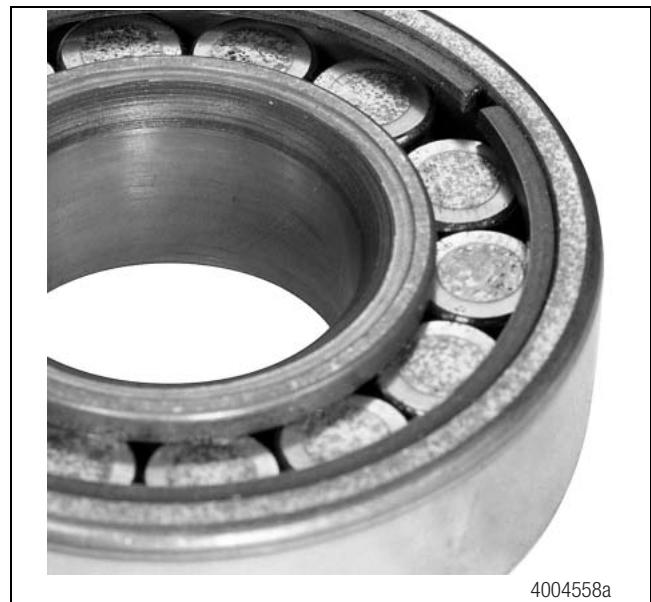
**Figure 3.12**

Water in lubricant damages bearing races and cups, and causes the hypoid gear set to wear prematurely. Figure 3.12 shows corrosion on the spigot bearing roller ends. Figure 3.13 shows etching damage on the bearing rollers, non-contact surfaces and bearing cage windows.

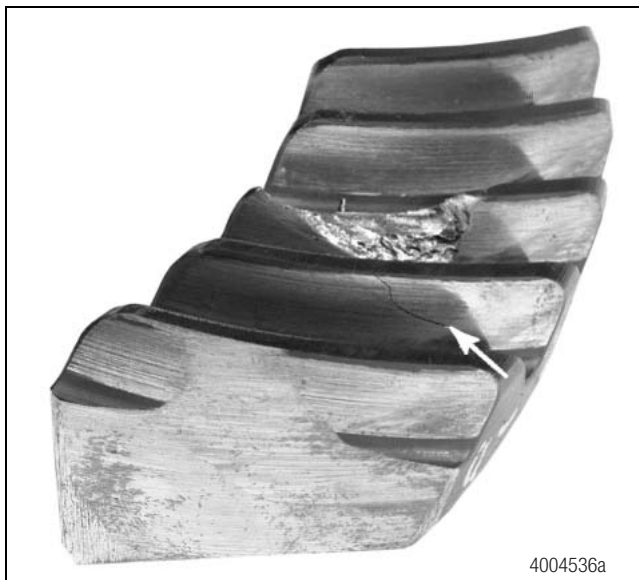
**Figure 3.14**

Flank cracking is a type of surface fatigue that's similar to spalling, because it causes metal to break into chips or fragments. When flank cracking occurs, initially cracks form along the length of the gear tooth. Once flank cracking appears, the tooth begins to crumble, and failure rapidly occurs. Figure 3.14.

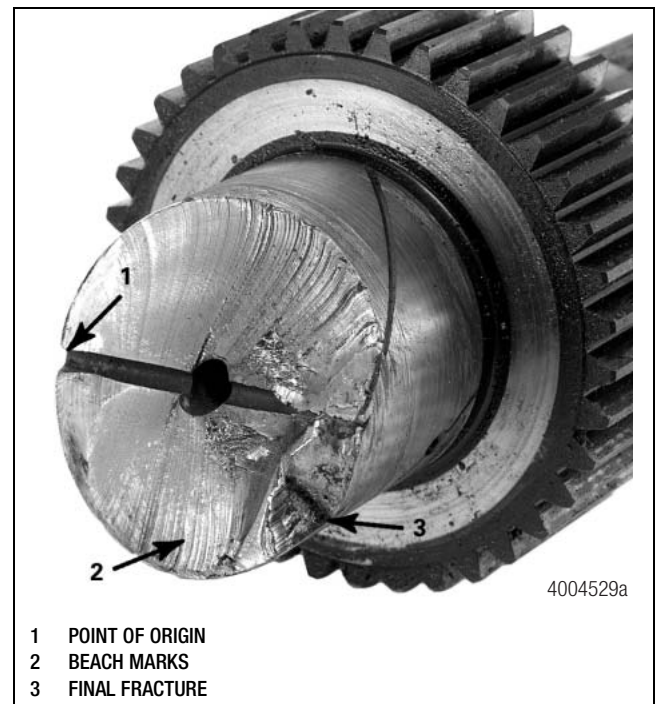
**Figure 3.15**

A fatigue fracture can be caused by cyclic torque overloads on a component, torsional vibration, and twisting and bending. A fracture begins at one or more points, which you can identify by the ratchet marks and subsequent beach marks that develop on the part. Figure 3.15.

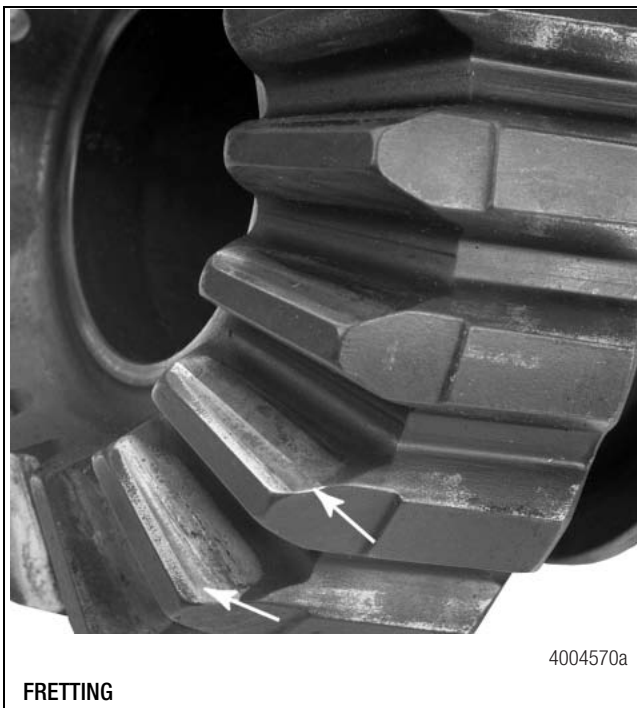
Figure 3.16

Inspect the back of the gear teeth on the forward drive axle carrier. If you find a contact line on the rear side of the gear teeth on the forward drive axle carrier, fretting has occurred. Figure 3.16.

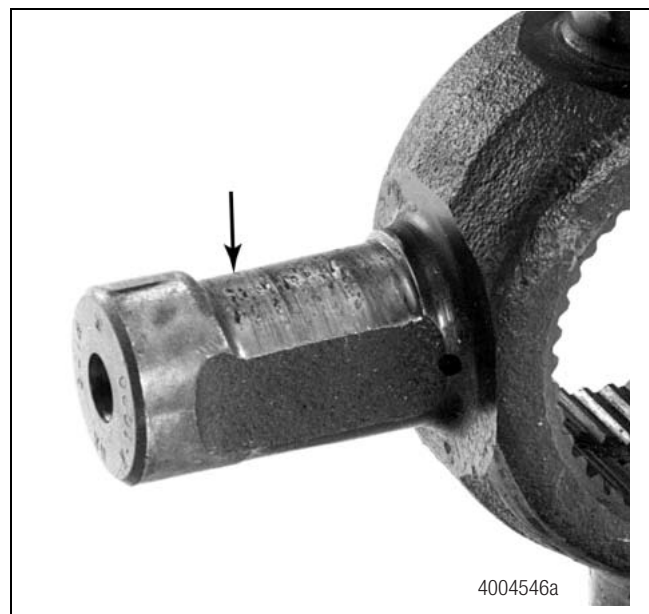
Figure 3.17

Galling, a type of surface fatigue that occurs when two unlubricated metal surfaces rub against each other. Galling is also called "metal transfer." Figure 3.17.

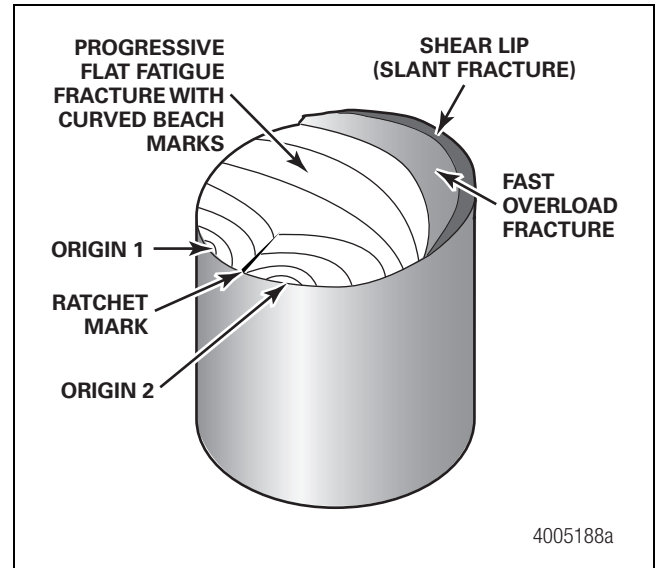
**Figure 3.23**

When more than one fatigue fracture occurs, beach marks form and create a raised, rough "ridge" between the origins of the fractures. This ridge is called a "ratchet mark." In this figure, you can see the ratchet mark between the first fracture, (Origin 1), and the second fracture, (Origin 2). Figure 3.23.

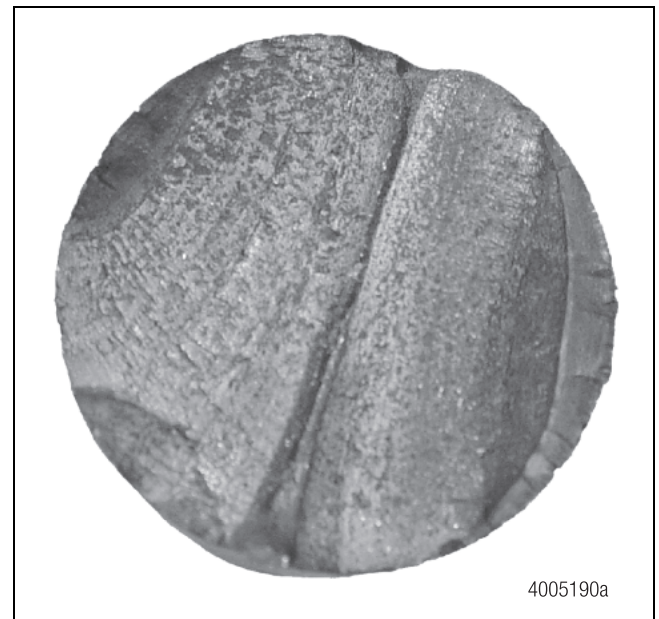
**Figure 3.24**

Reverse bending is a type of fatigue that breaks a component in two directions, 180 degrees apart. Beach marks occur on each side of the fractured area and move toward the center of the component. Figure 3.24.

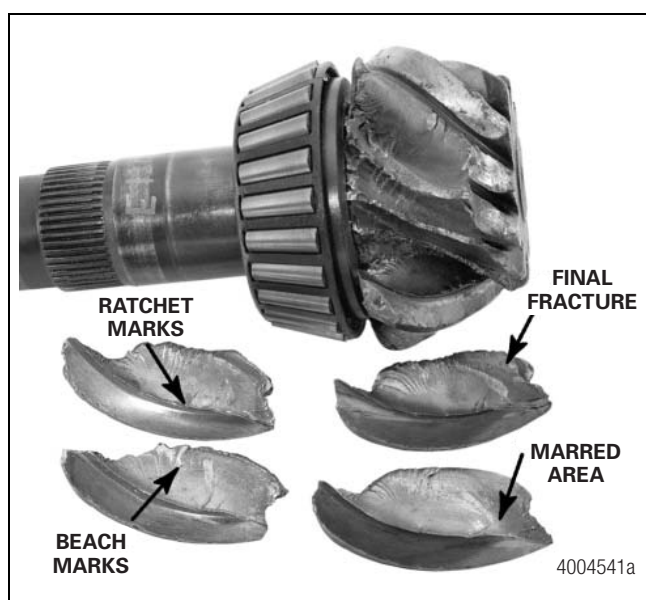
Figure 3.25 shows a less common root beam fatigue fracture that occurred when shock load was strong enough to crack the tooth, but not to break the entire tooth.

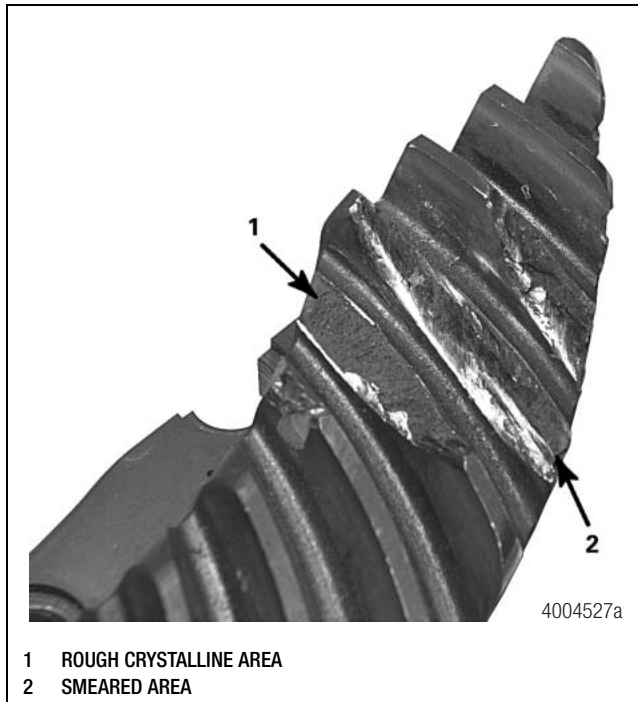
**Figure 3.27**

Figure 3.27 shows a hypoid gear seat damaged by shock load. Typically, the first tooth breaks at the heel, the second tooth breaks completely, and the third tooth breaks at the toe. The figure shows how two of the teeth were damaged by the pinion rubbing against the area where the teeth broke.

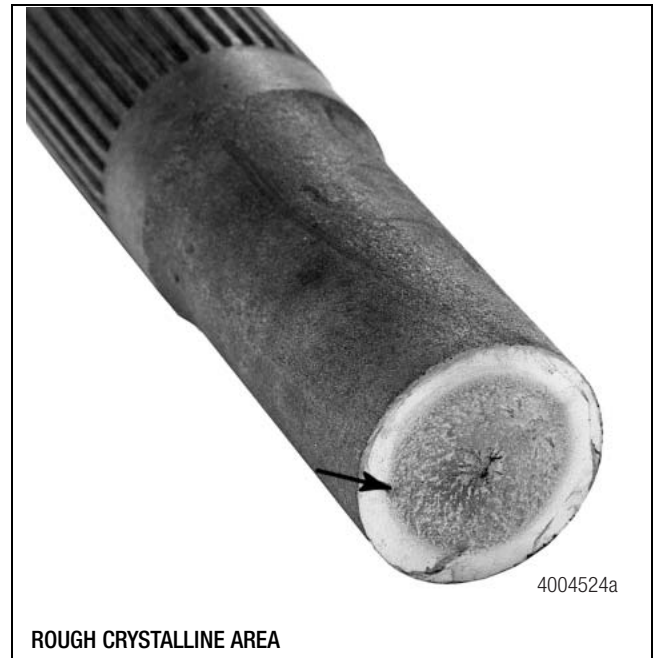
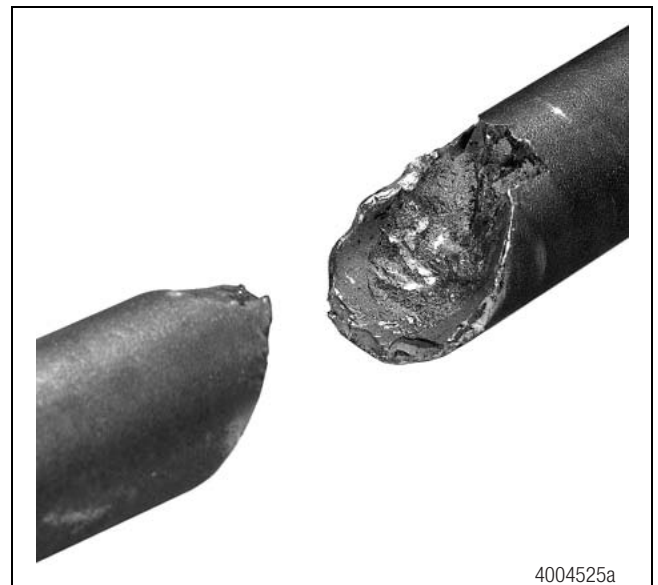
Figure 3.28 and Figure 3.29 show an axle shaft damaged by shock load that fractured perpendicular to its centerline, which caused a rough, crystalline surface to form on the shaft. This type of failure is also called “torsional shear.” If the fracture is at a 45-degree angle to the centerline, the damage is called “torsional tensile” failure.

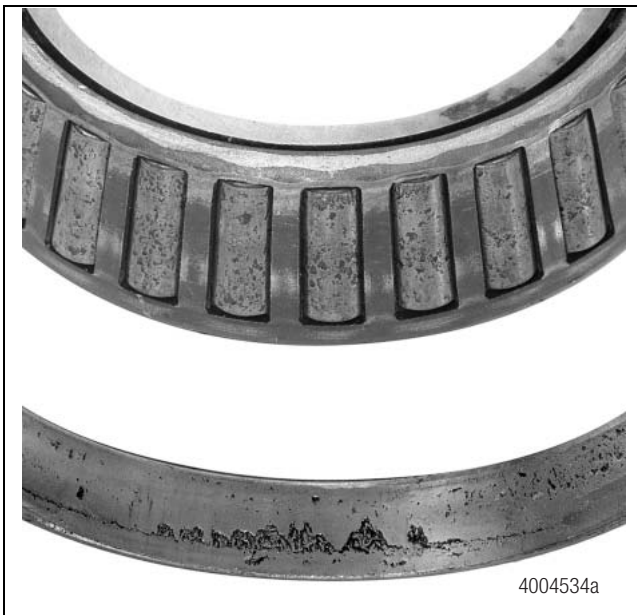
Some causes of spalling are prolonged stress from excessive load applications; or the components operate with no lubricant or a lubricant that doesn't meet the correct specification. Spalling can also occur when components are operated beyond the maximum mileage range. Figure 3.30 and Figure 3.31.

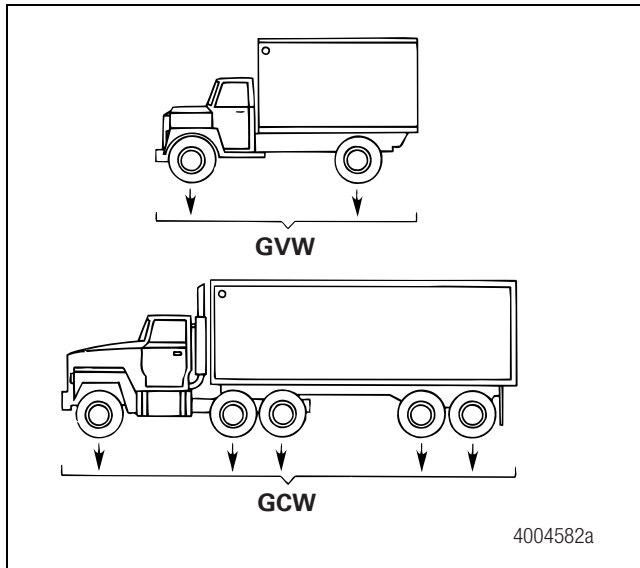
Figure 4.1

Axles operated under conditions that exceed their design capacity can wear prematurely. Fatigue, which can result from load cycles that exceed a carrier's gross vehicle weight rating (GVWR) or gross combined weight rating (GCWR), can cause an axle to fail. Figure 4.1.

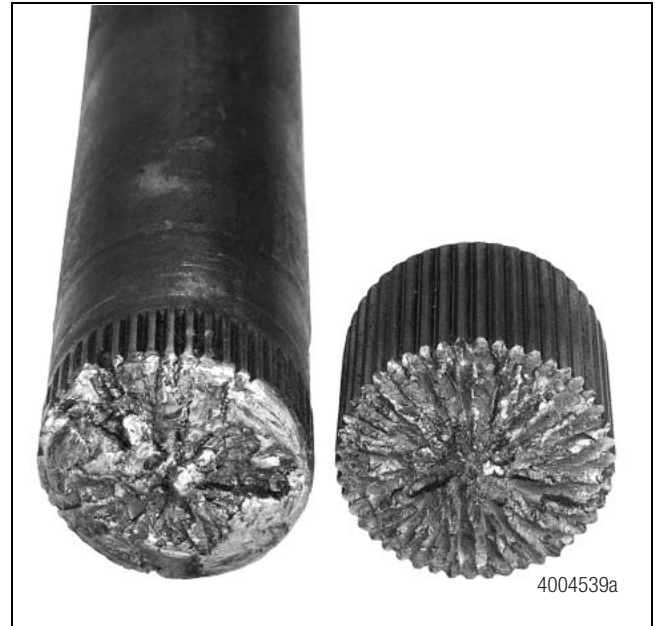
Figure 4.5 shows a shaft damaged by torsional fatigue. As the splines continued to weaken, the metal formed a star-shaped radial pattern, eventually breaking the shaft at the center.

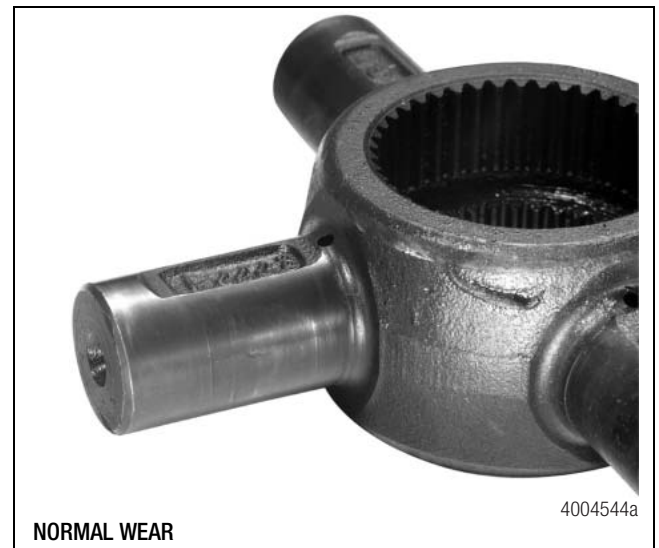
Figure 4.12, Figure 4.13, Figure 4.14, Figure 4.15 and Figure 4.16 show how spinout caused a pinion cross to fail. Damage progresses from normal wear, to moderate premature wear, and then to heavy wear; and finally, the pinion cross fails.

**NORMAL WEAR**

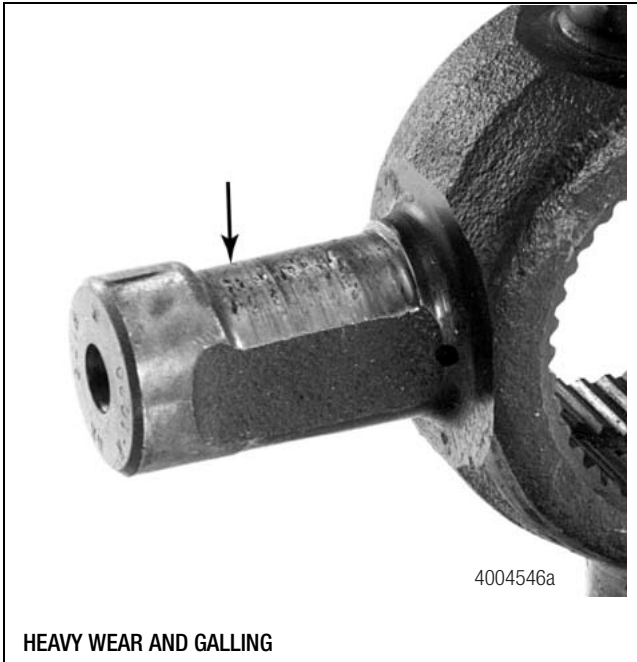
Figure 4.14

HEAVY WEAR AND GALLING

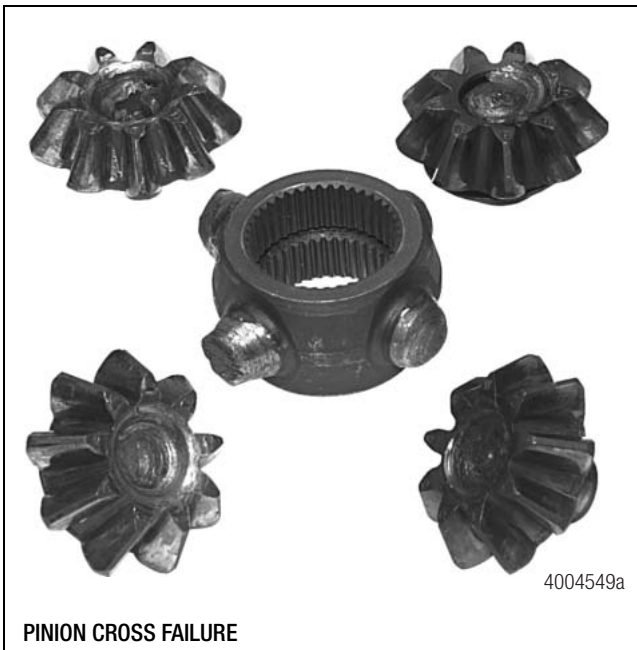
PINION CROSS FAILURE

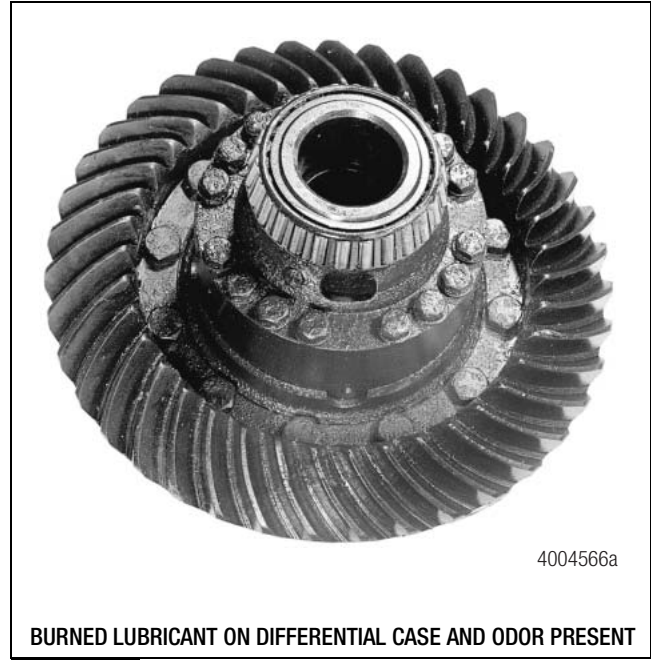
BURNED LUBRICANT ON DIFFERENTIAL CASE AND ODOR PRESENT

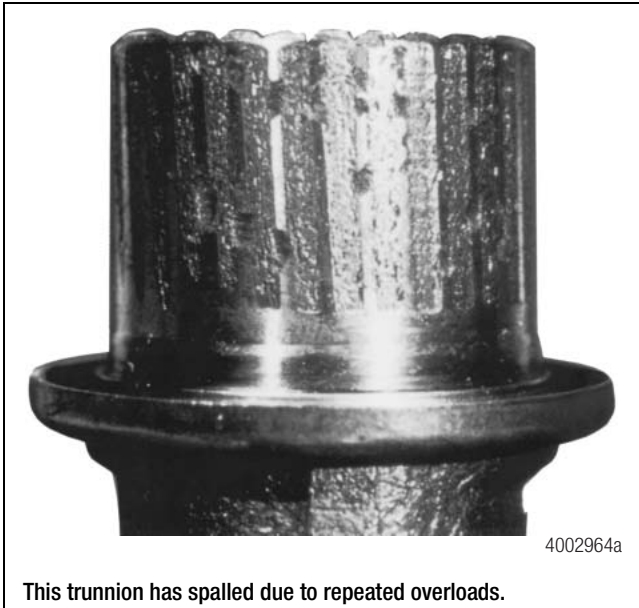
This trunnion has spalled due to repeated overloads.

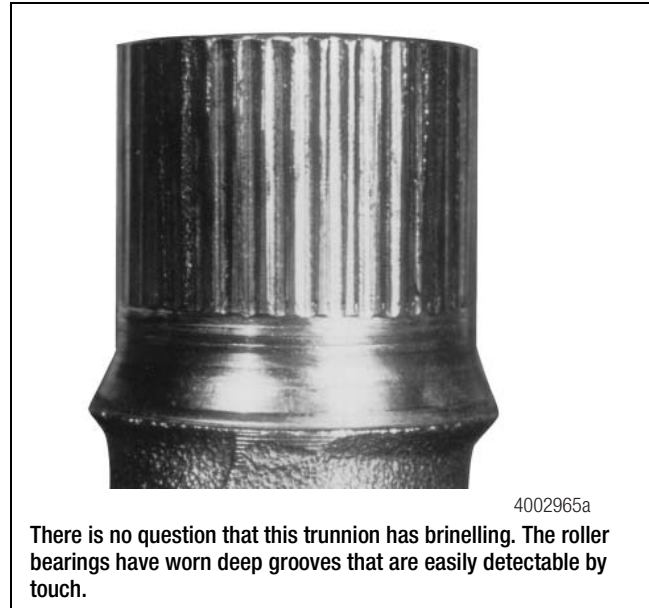
There is no question that this trunnion has brinelling. The roller bearings have worn deep grooves that are easily detectable by touch.

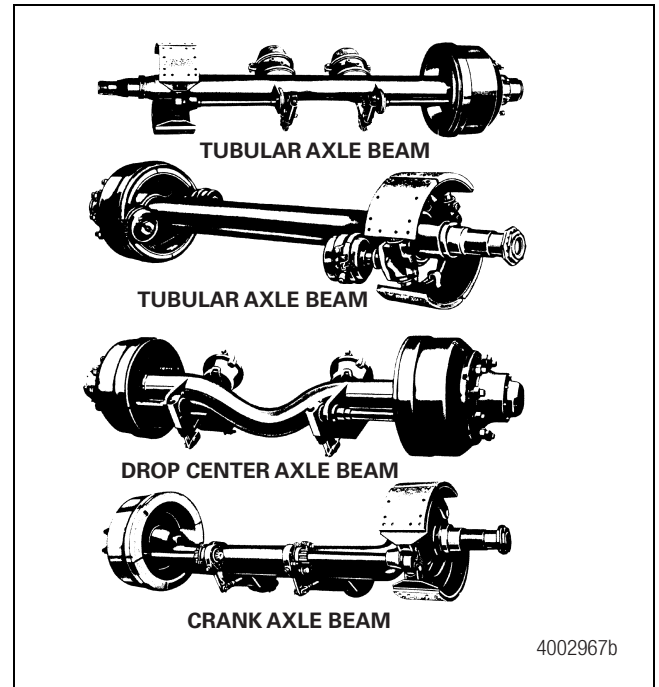
**Figure 6.1**

Meritor trailer axles are available in a variety of sizes and configurations, and are designed and rated for specific load applications. Figure 6.1. The gross axle weight rating (GAWR) specifies the maximum load limit for a trailer. Trailer axles that are operated above their GAWR can be damaged by torsional fatigue and bending fatigue.

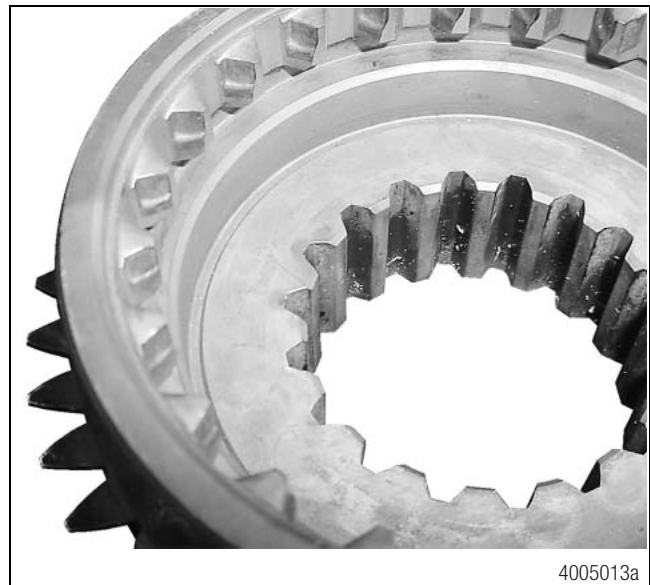
**CLUTCHING TEETH DAMAGE DUE TO TORSIONAL VIBRATION**

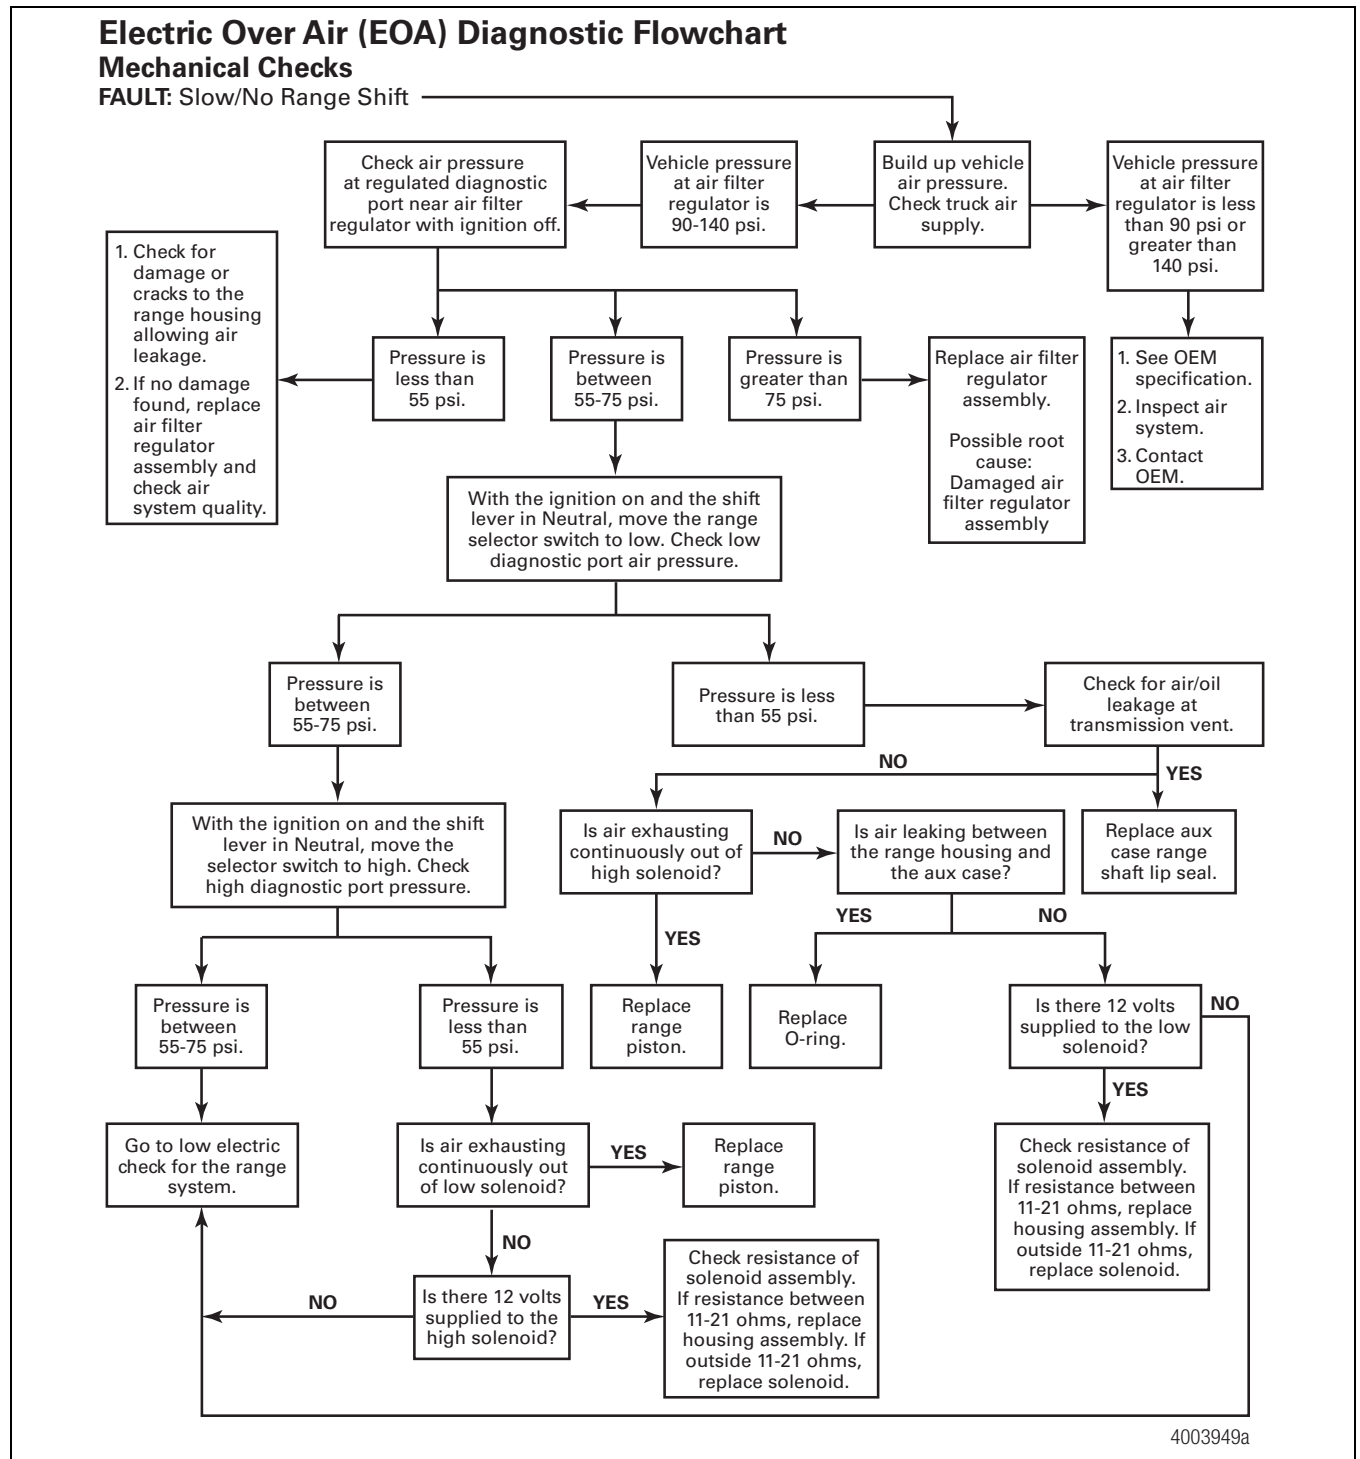
**Figure 9.54**

1. Mechanical Checks — Follow the mechanical checks flowchart to verify that all mechanical systems function correctly. Repair all mechanical issues BEFORE you perform electrical checks. Figure 9.54.

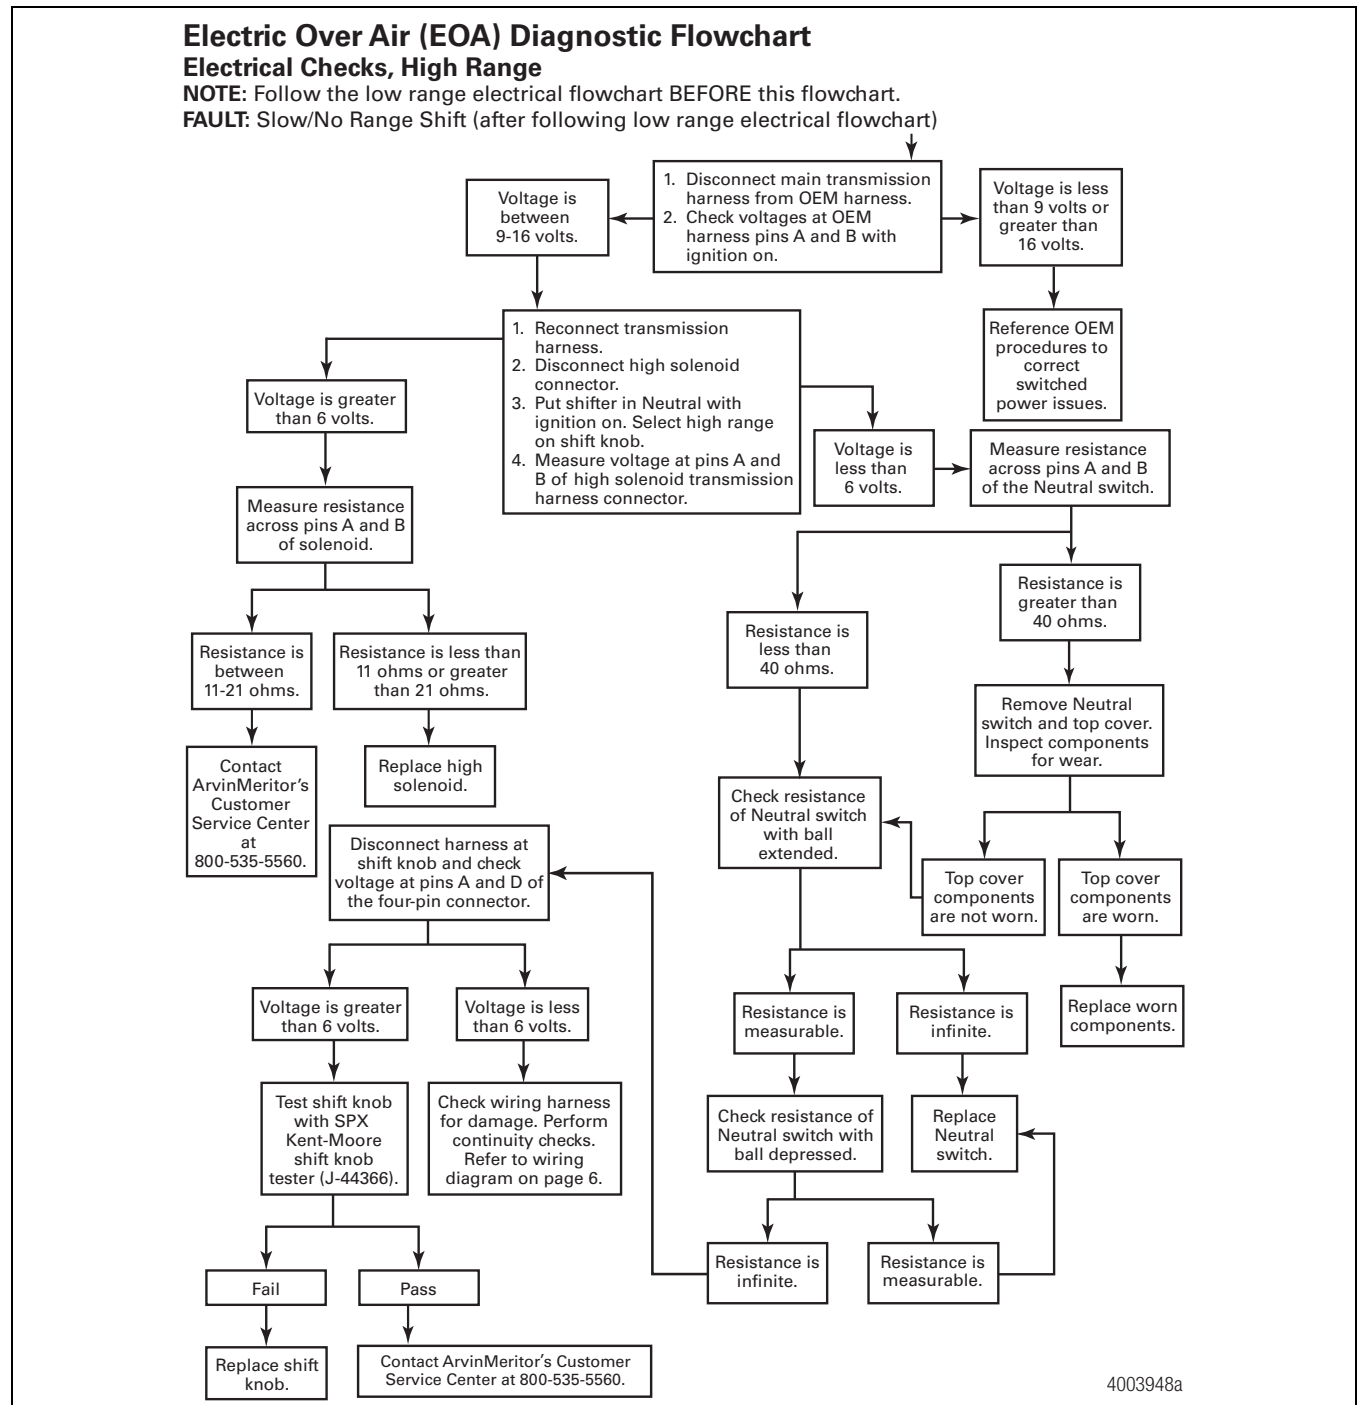
Figure 9.56

3. High Range Electrical Checks — Follow the high range electrical checks flowchart to verify that the high range electrical system functions correctly. Perform high range electrical checks AFTER mechanical checks and low range electrical checks. Figure 9.56.
